# New York Presbyterian The University Hospital of Cornell

## Retro-Commissioning Report

Vanderweil Project No.:26607.00

October 24, 2012

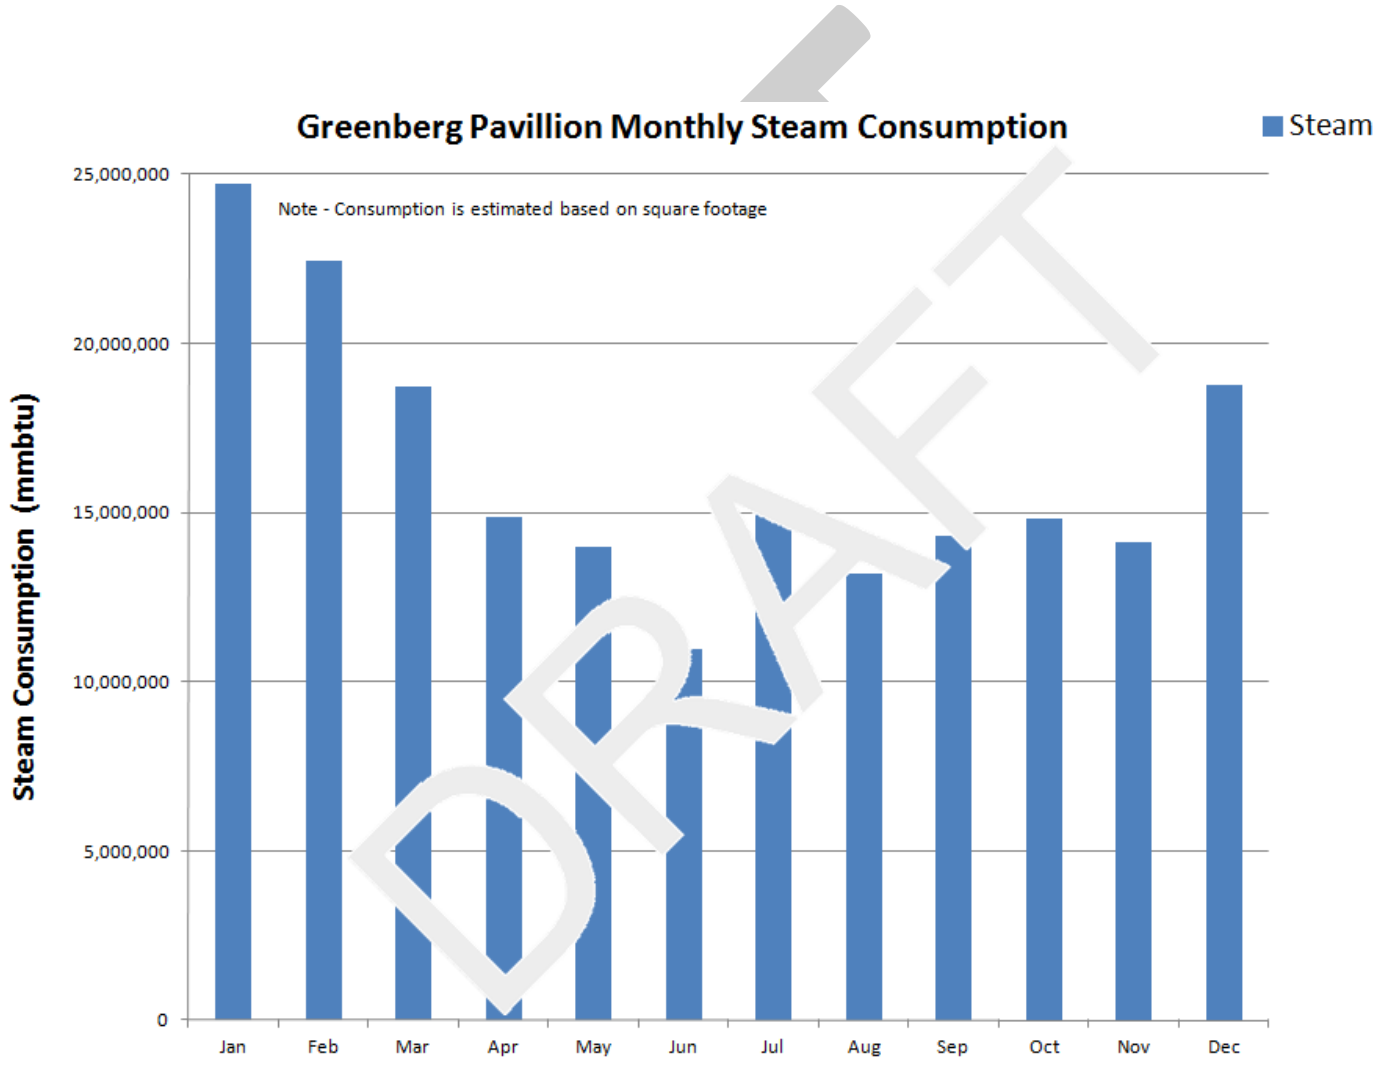
Greenberg Pavilion Building Estimated Energy Consumption		
Greenberg Square Footage	982,411	sf
Greenberg Steam Consumption	196,317,441	lbs
Greenberg CHW Consumption	2,729,266	ton hrs
Greenberg Electric Consumption	10,465,626	kwh
Greenberg EUI	260

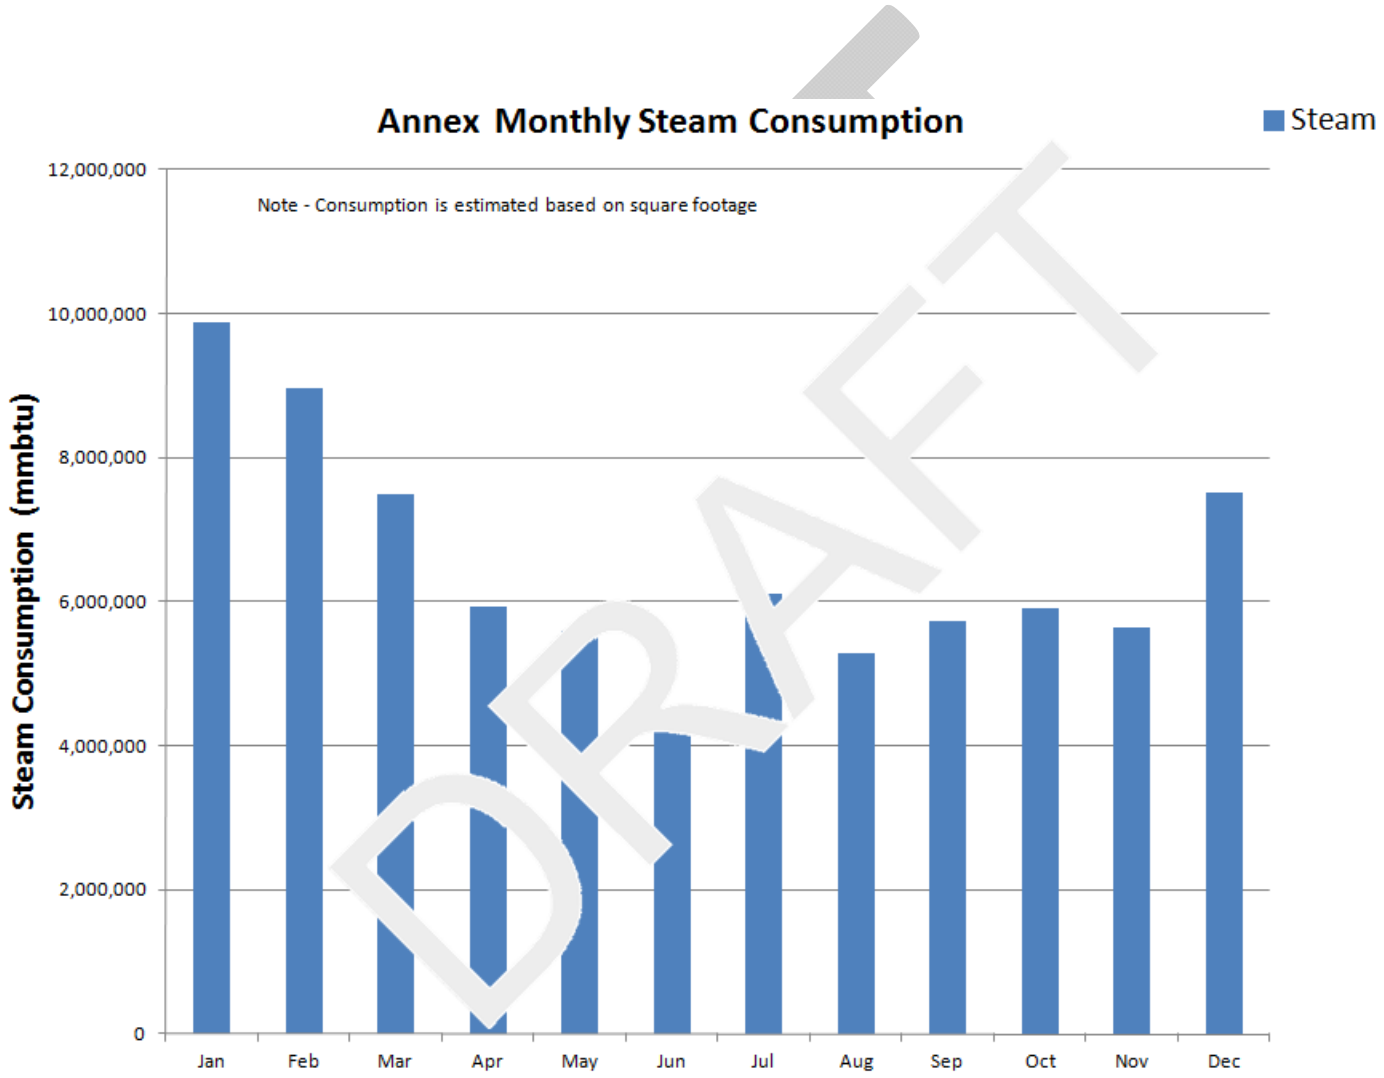
Annex Building Estimated Energy Consumption		
Annex Square Footage	392,573	sf
Annex Steam Consumption	78,448,725	lbs
Annex CHW Consumption	1,035,494	ton hrs
Annex Electric Consumption	4,182,079	kwh
Annex EUI	258
